DUTCH
SAFETY BOARD

Preliminary report Crash involving Malaysia Airlines Boeing 777-200 flight MH17

Hrabove, Ukraine - 17 July 2014

Preliminary report

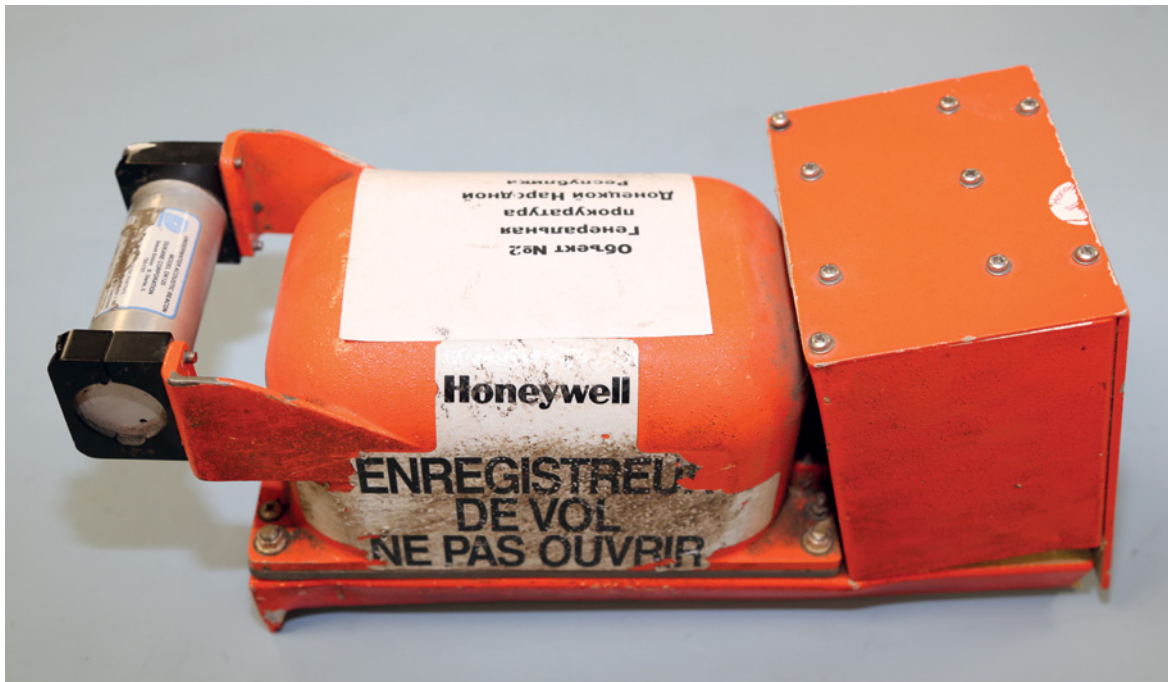
The housing of the CVR (figure 4) had been damaged and, although the model and serial numbers were unreadable on the data plate, the serial number 1366 - matching the one provided by Malaysia Airlines - was found stamped on the underside of the chassis. The external damage found on the CVR is consistent with impact damage, the internal memory module was intact. The recording capacity of this recorder is 30 minutes.

Figure 4: Cockpit voice recorder. (Source: AAIB)

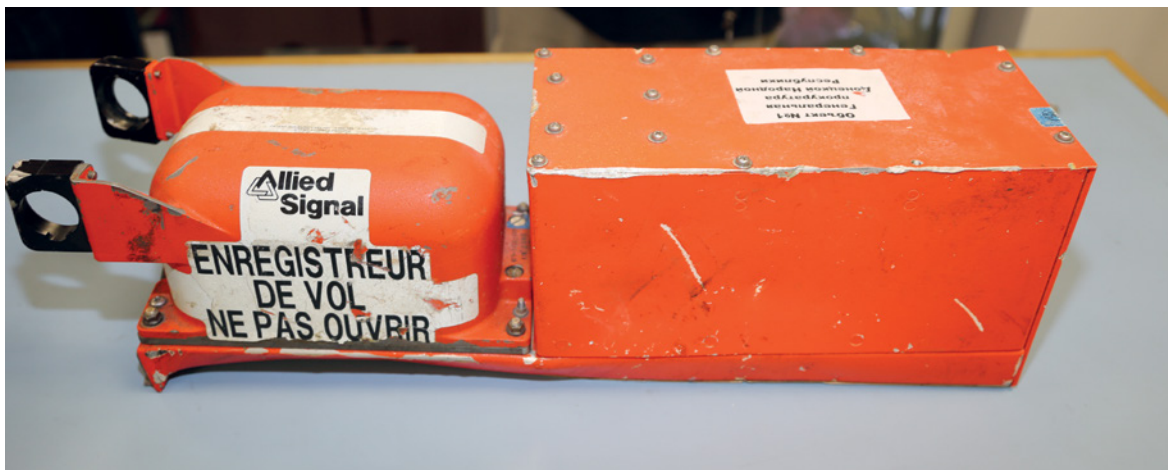
The label on the housing of the FDR (figure 5) showed that it was Allied Signal Model Number 980-4700-003 with Serial Number 2196. These details matched the details provided by Malaysia Airlines. The recorder was found damaged but the internal memory module was intact. The external damage found on the FDR was consistent with impact damage. The FDR, which can record 25 hours of operational data, was successfully downloaded and contained valid data from the occurrence flight.

Figure 5: Flight data recorder. (Source: AAIB)

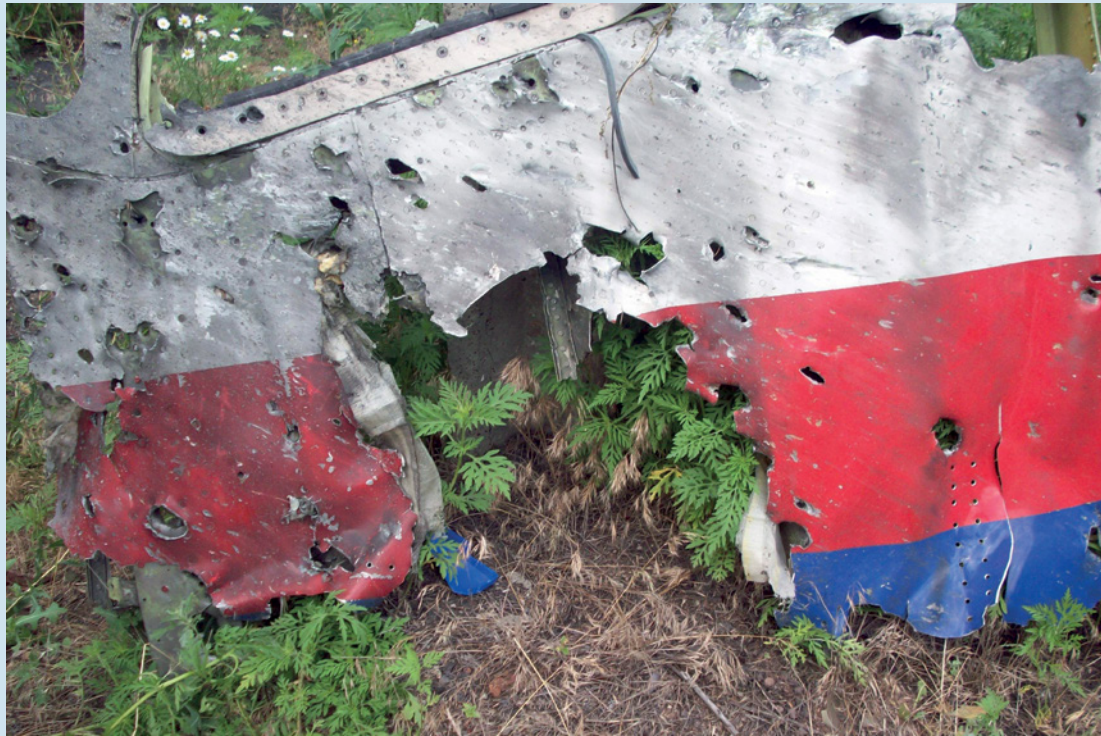
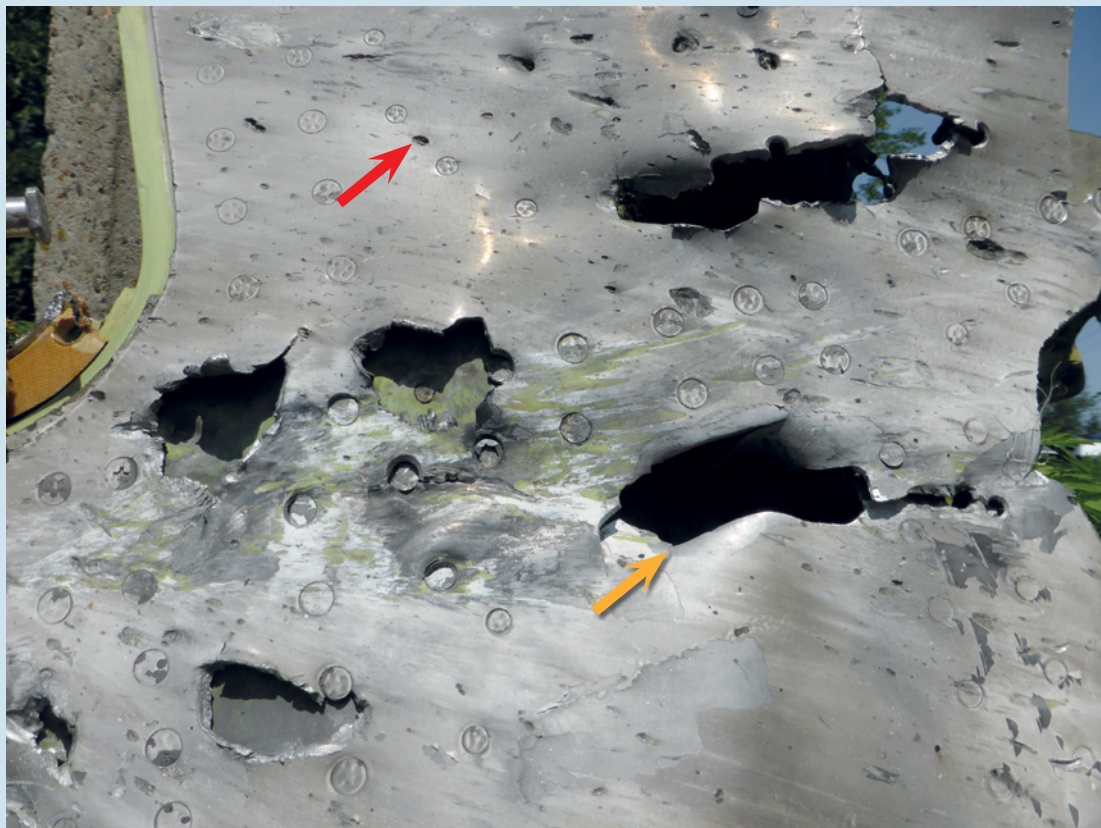
Photographs from the some wreckage showed that a number of pieces contained multiple holes and indentations. An example of a piece of wreckage containing such damage was a piece of skin from below the left cockpit window (figure 8) found in the town of Petropavlivka.

Figure 8: Forward fuselage skin from below the left cockpit window containing numerous small holes and indentations (above); enlarged image of the right upper corner of this skin (below) showing puncture holes (orange arrow) and pitting (red arrow). (Source: DCA and AFP)

Noting that the investigation team has not yet had the opportunity to recover these components for forensic examination, photographs from the wreckage indicated that the material around the holes was deformed in a manner consistent with being punctured by high-energy objects. The characteristics of the material deformation around the puncture holes appear to indicate that the objects originated from outside the fuselage.

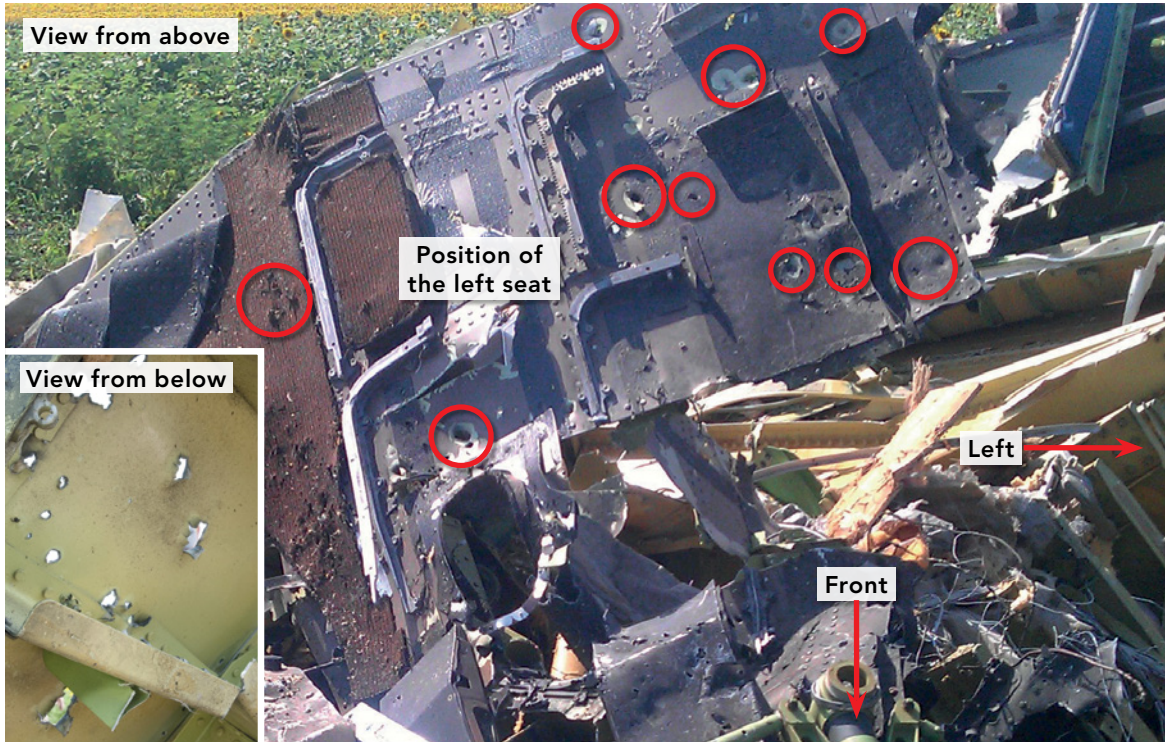
Puncture holes identified in images of the cockpit floor suggested that small objects entered from above the level of the cockpit floor (figure 10).

Figure 10: Cockpit floor with floor parts showing puncture holes (red circles) coming from above the floor.
(Source: NBAAI)

The pattern of damage observed in the forward fuselage and cockpit section of the aircraft was consistent with the damage that would be expected from a large number of high-energy objects that penetrated the aircraft from outside.

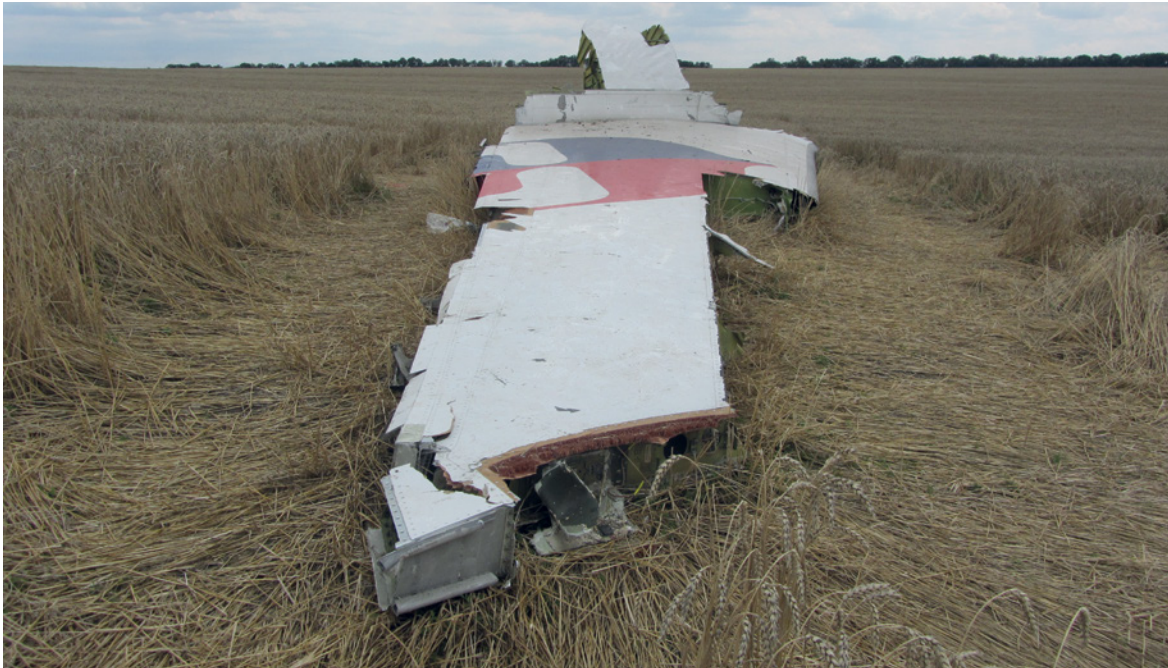
The vertical tail (figure 12) was located in a field to the south of Hrabove, approximately 8 km from the last recorded FDR position. The vertical tail was still attached to a portion of the upper rear fuselage. The rudder and a portion of the vertical tail's leading edge were not attached. The remains of the rear fuselage, horizontal stabiliser centre section, and items from the cabin were found about 100 metres north of the vertical tail.

Figure 12: Vertical tail. (Source: DCA)

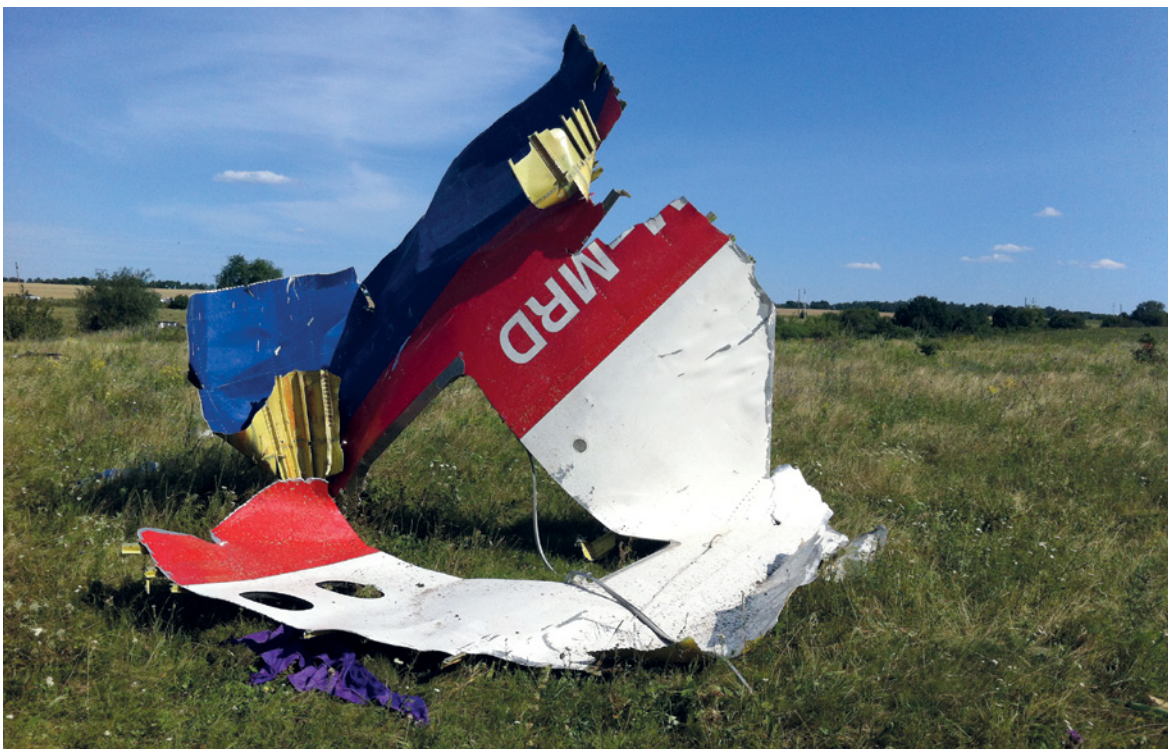
A section of aft fuselage skin from the right side (figure 13) was located 330 metres west of the vertical tail, and the left wing tip and right horizontal stabilizer were also in this location. The left horizontal stabilizer was found another 330 metres to the west.

Figure 13: Aft fuselage skin, right side, with partial registration of the aircraft. (Source: NBAAI)
