**TNO report**

**TNO 2016 R10735**

**Investigation into a Periodic Technical  
Inspection test method to check for presence  
and proper functioning of Diesel Particulate  
Filters in light-duty diesel vehicles**

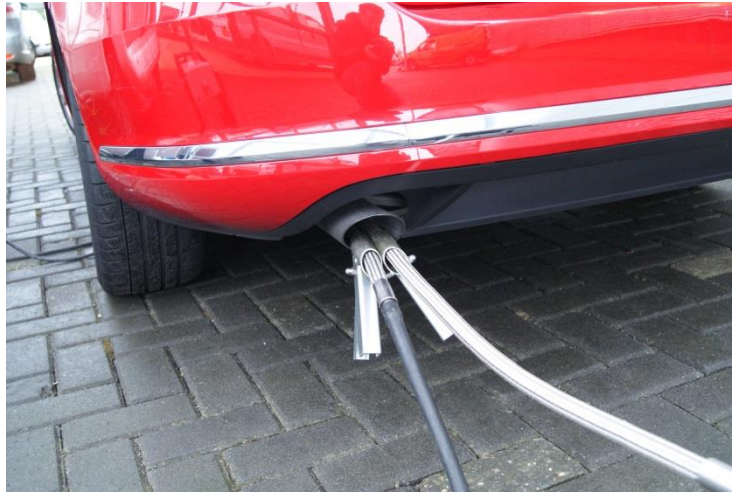
Figure 9 The probes of the LPA and EDA2 opacity meters were both inserted into the tailpipe during the free acceleration test and the high idle speed test. This way, both smoke meters measured simultaneously. Also see Figure 4.

In the free acceleration test, the probes of both smoke meters were inserted into the tailpipe, in line with the exhaust flow (Figure 9). It is assumed that both meters are charged with equal exhaust gas mixture.

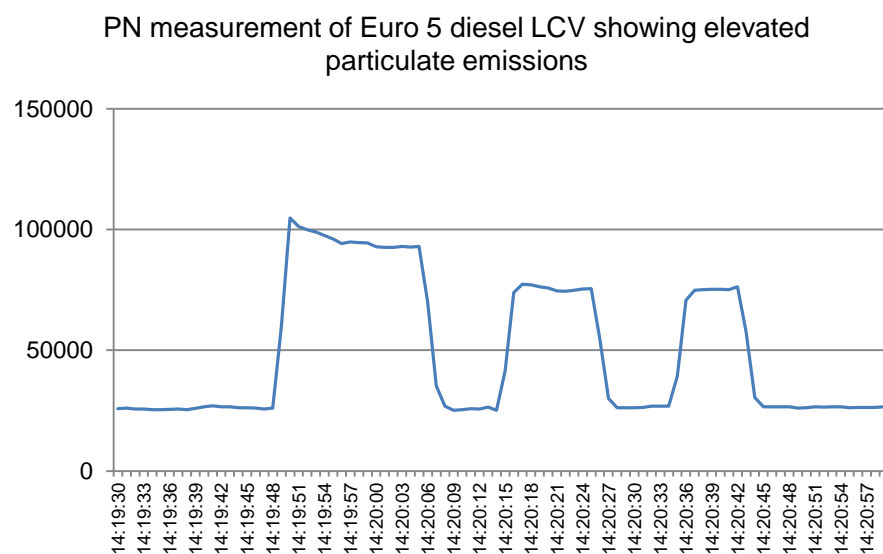
Figure 14 PN measurement on a Euro 5 LCV showing elevated particulate emissions. The measurement was performed three times to check for reproducibility.

Figure 14 shows the PN measurement performed on a Euro 5 LCV. As can be seen in the figure, the background particulate matter concentration on the test location was around 25,000 particles per  $\text{cm}^3$ . Three tailpipe measurements were performed, represented by the three peaks at approximately 105,000, 76,000 and 75,000 particles per  $\text{cm}^3$ . For this vehicle, an average PN emission of a little over 86,000 particles per  $\text{cm}^3$  was reported.

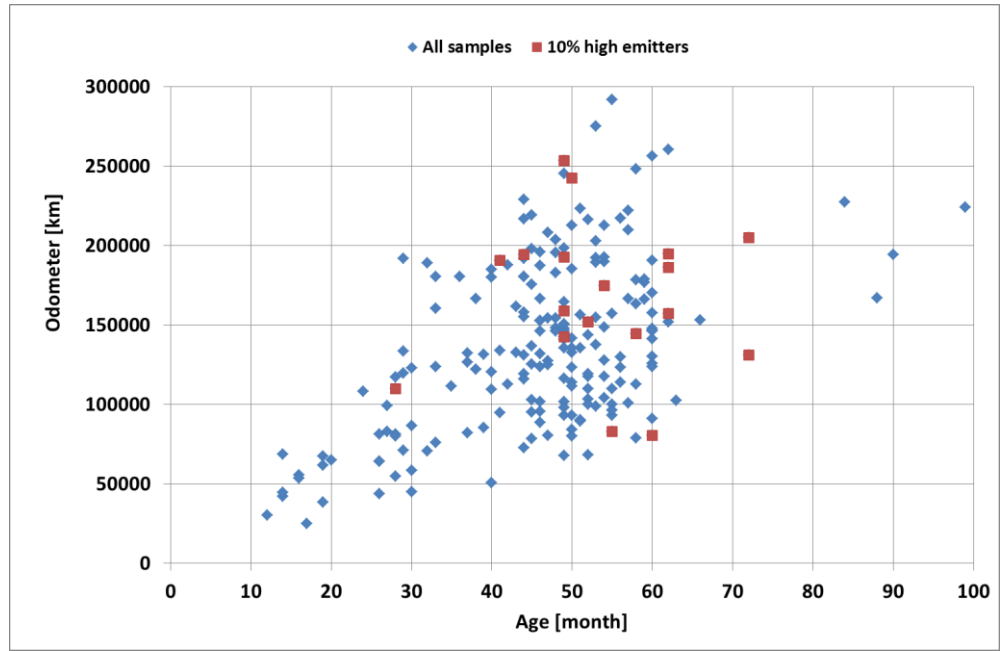
Figure 19 Age and odometer readings of the tested vehicles.

In Figure 19, the so-called 10% high-emitters are shown in red. Based on a Particulate Number (PN) emission of more than  $250,000 \text{ \#/cm}^3$ , the 10% 'highest-PN vehicles' were identified. As can be seen, most of the vehicles with high PN numbers are 4 to 5 years old, with a mileage between 130,000 and 190,000 km.

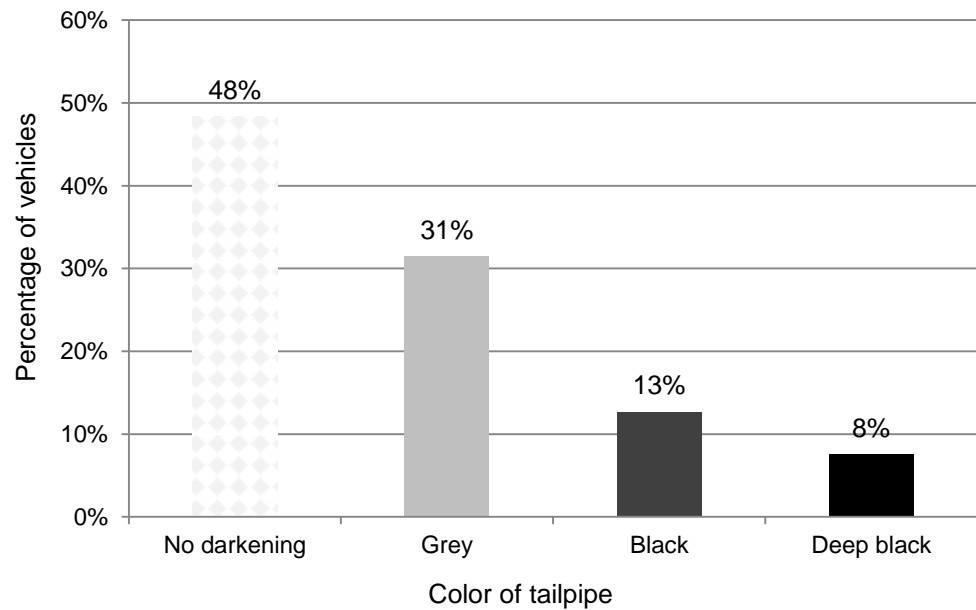
Figure 20 21% of the tested vehicles showed a noticeable darkening in the TST.

79% of the vehicles were found to have a clean exhaust pipe or showed some deposits (scoring 0 or 1). Most of these vehicles showed low smoke values and PN counts in the following tests. A total of 43 vehicles (21%) had tailpipes that were blackened or severely blackened, scoring 2 or 3.

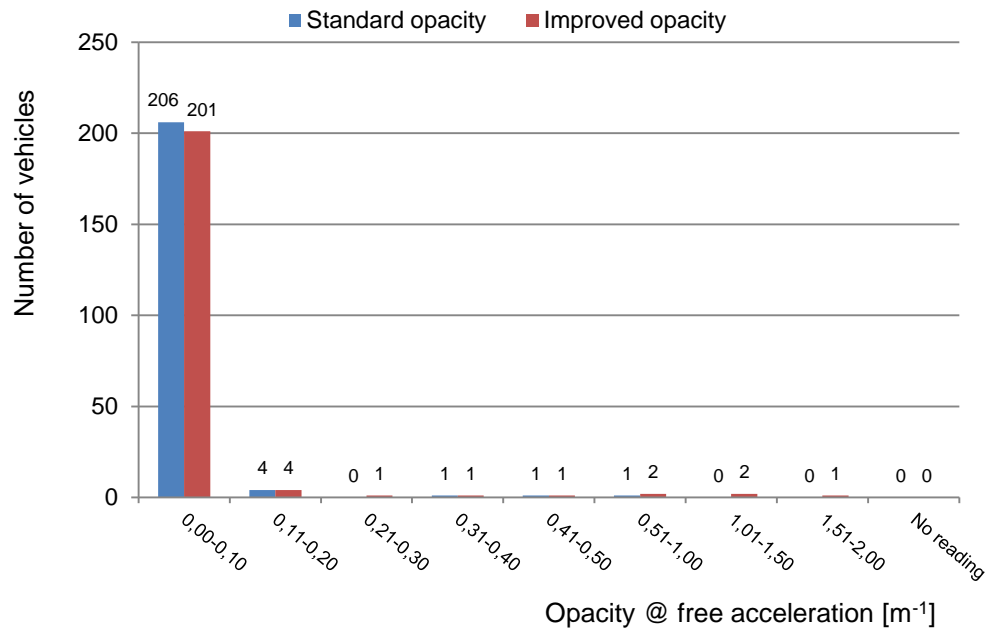
Figure 21 Standard and improved opacity test results.

Table 8 and Figure 21 show the test results of both opacity meters. Based on the standard opacity meter test results ("SO-EDA2" in the table), seven vehicles (3,3%) have an opacity of over  $0,10 \text{ m}^{-1}$ . Using the improved opacity meter, the opacity of twelve vehicles exceeds  $0,10 \text{ m}^{-1}$  (5,6%). In other words, based on these measurements 3,3 to 5,6% of tested vehicles have a malfunctioning or missing DPF; 94 to 96 percent of the tested vehicles has a well-functioning DPF.

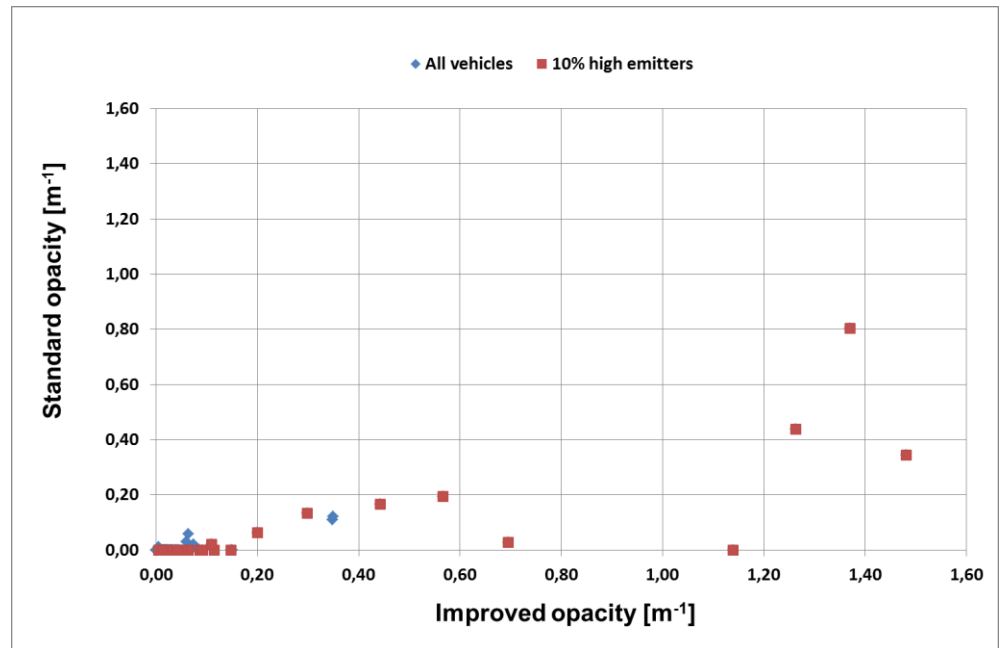
Figure 30: Relationship between improved and standard opacity free acceleration test results.

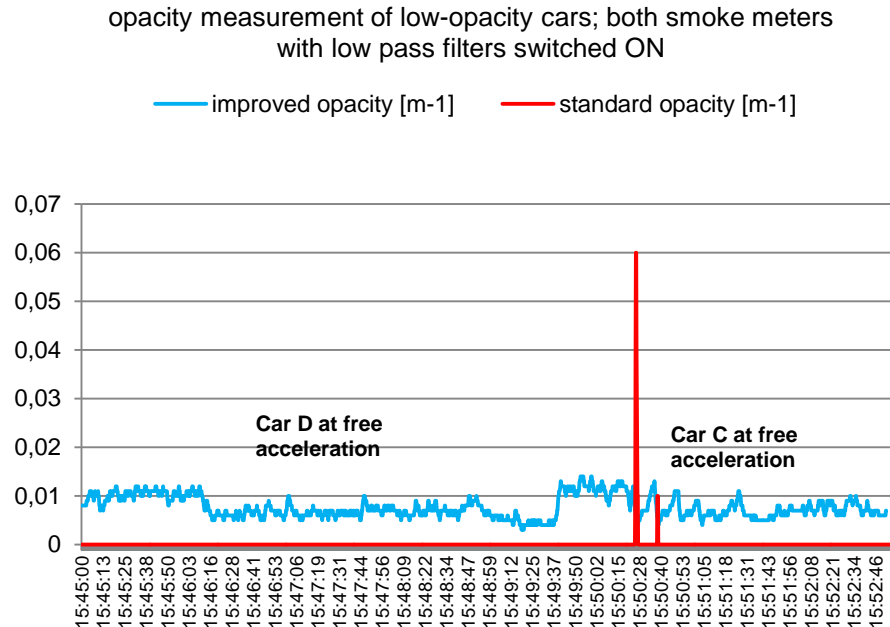
Figure 34 Results of opacity measurement of two cars with low smoke values, using the standard opacity meter and the improved opacity meter, both in the *filtered* mode.

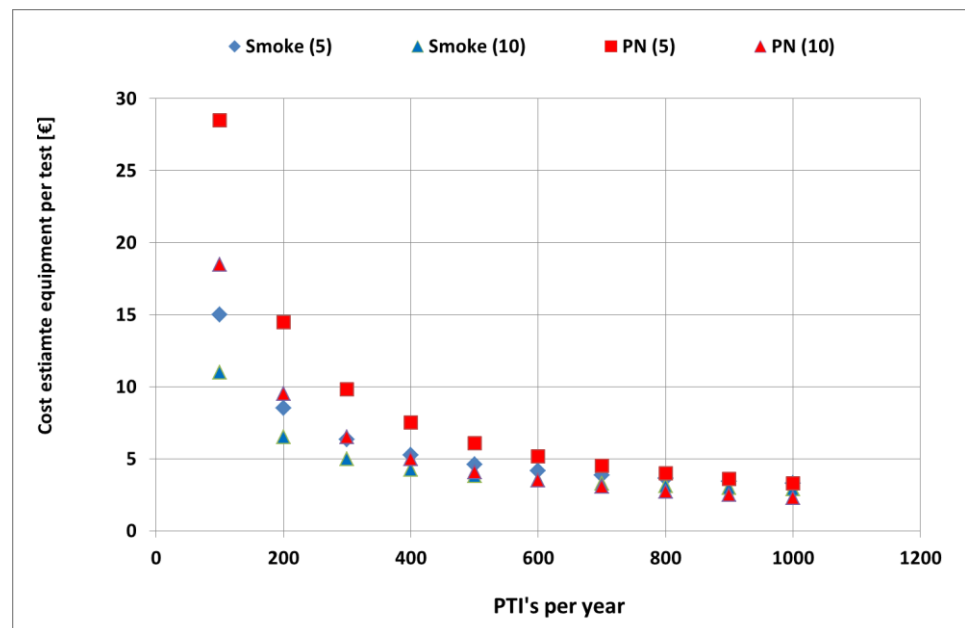
Figure 41 Cost estimate of single PTI DPF tests with smoke or PN meters with economic lifetimes of test equipment of 5 and 10 years.
